Title of Work: *Securing of pilot ladders at intermediate lengths – testing*

Reference No: *NCC453*

Work for: *International Maritime Pilots Association*

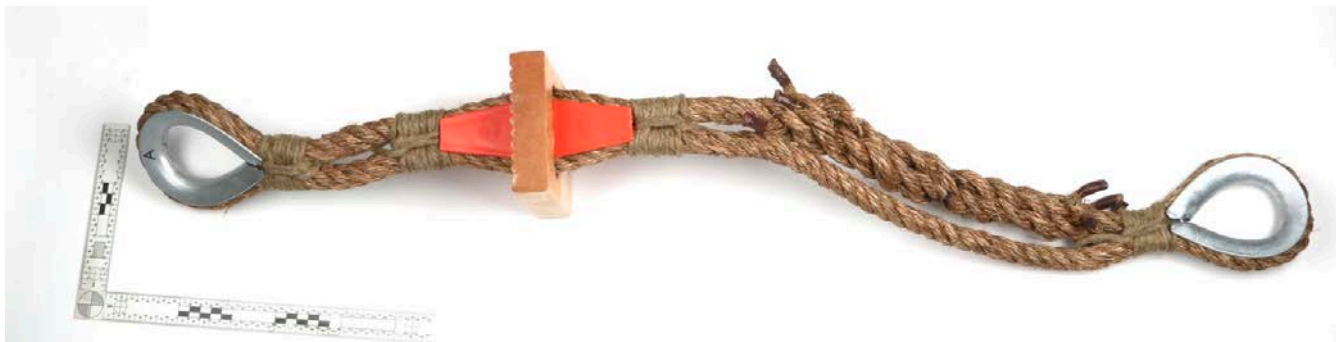
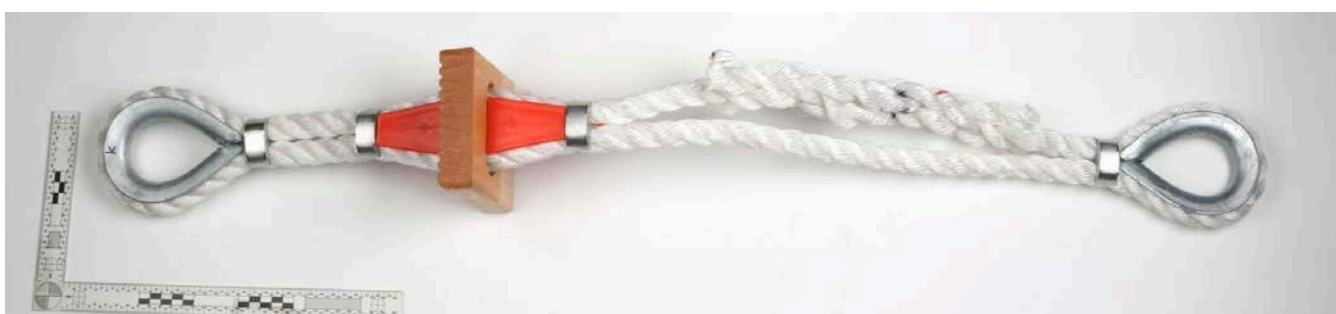
A: 20 mm manila rope, with step and manila rope seizing (sample B the same)

I: 20 mm polypropylene rope, with step and polypropylene seizing (sample J the same)

K: 20 mm polypropylene rope, with step and metal clip seizing (sample L the same)

Figure 10: As received condition of samples (with step) for WP1.

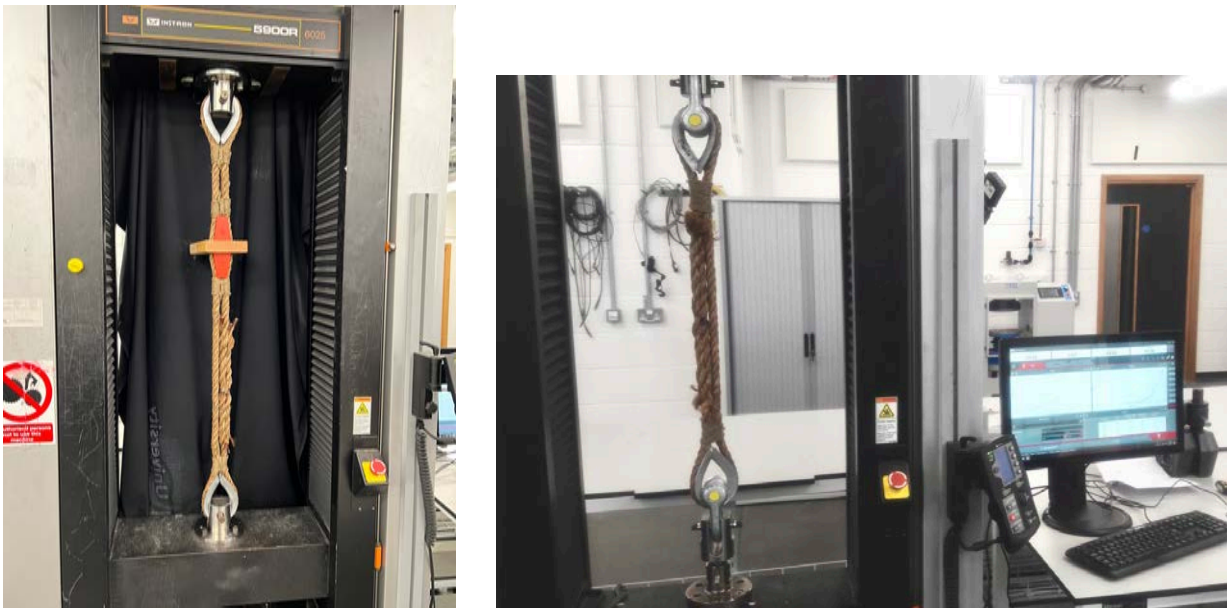
Figure 11: Tested in tension on an Instron 6023 Electromechanical test machine, operating with Instron Bluehill Universal software and fitted with a 100 kN load cell.

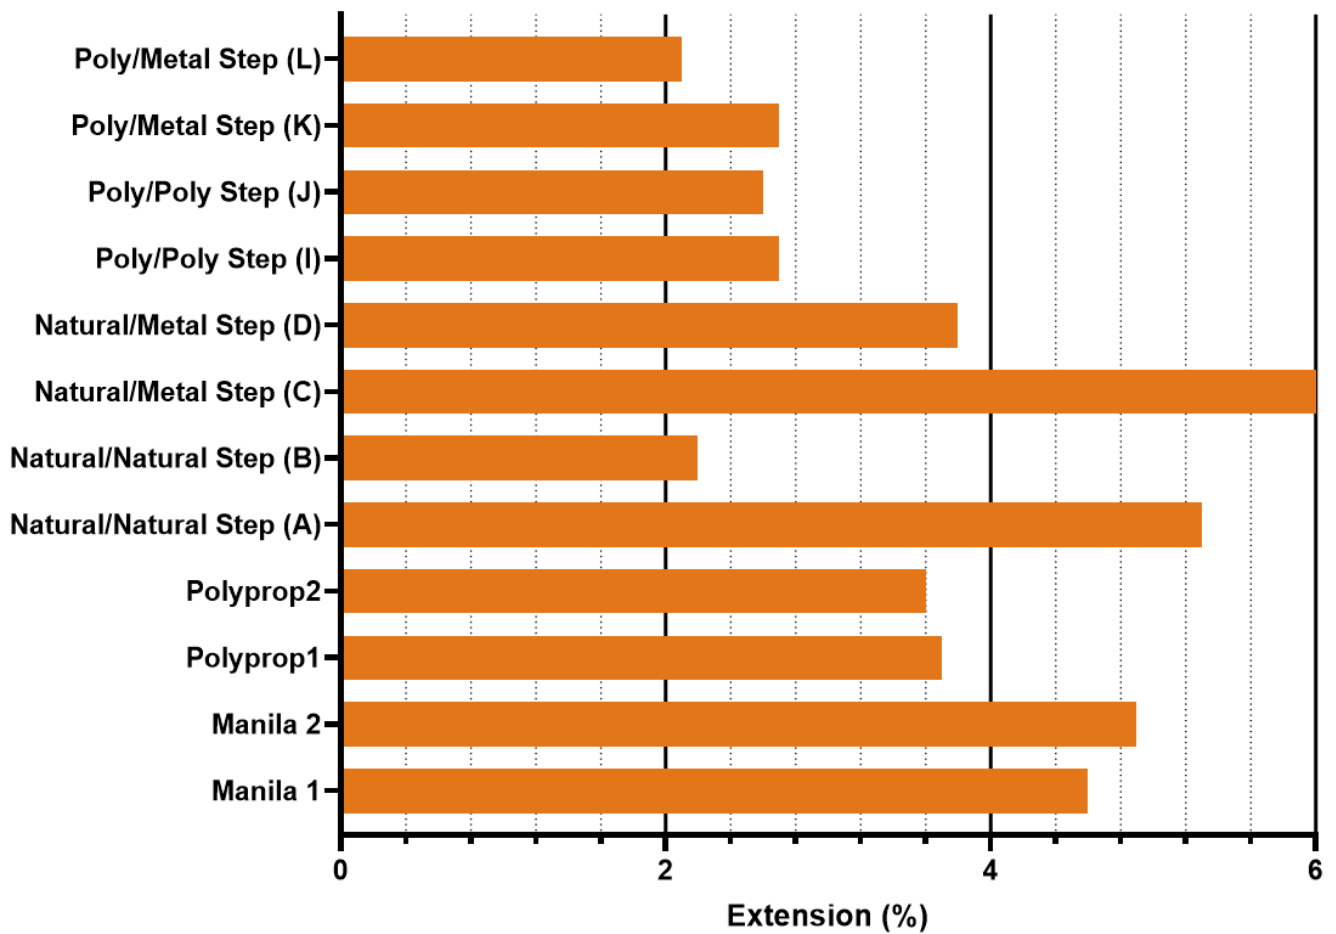
Figure 12: Residual extension in % after the first run for the ropes with and without the steps.

- Where multiple examples were provided – there was consistency.
- All ropes needed to bed in to obtain a consistent extension under load.
- Under 10 kN tension:
 - Polyprop extended by 8-9%,
 - Manila extended by 4-5%,
 - Adding steps made them slightly more 'stretchy',
 - No measurable effect of metal or rope/fibre fixing was observed.

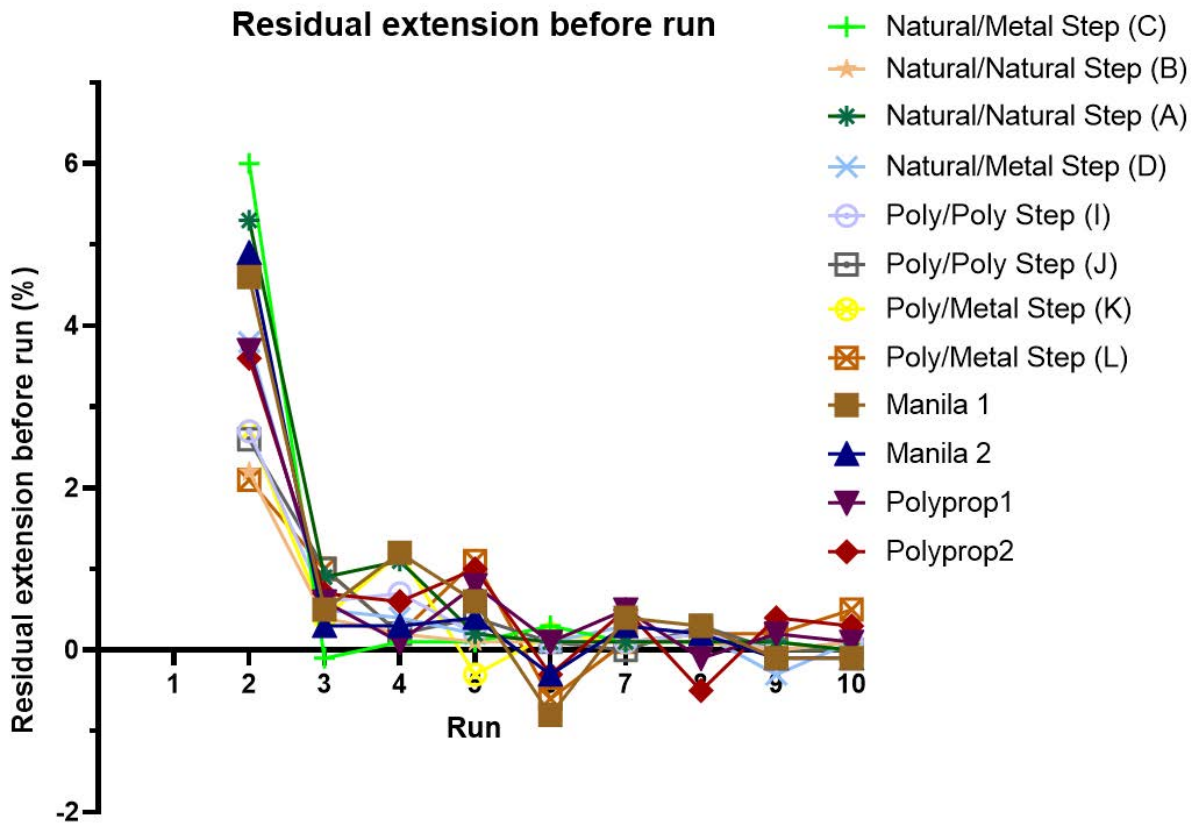
Figure 13: The residual extension in % before a run.

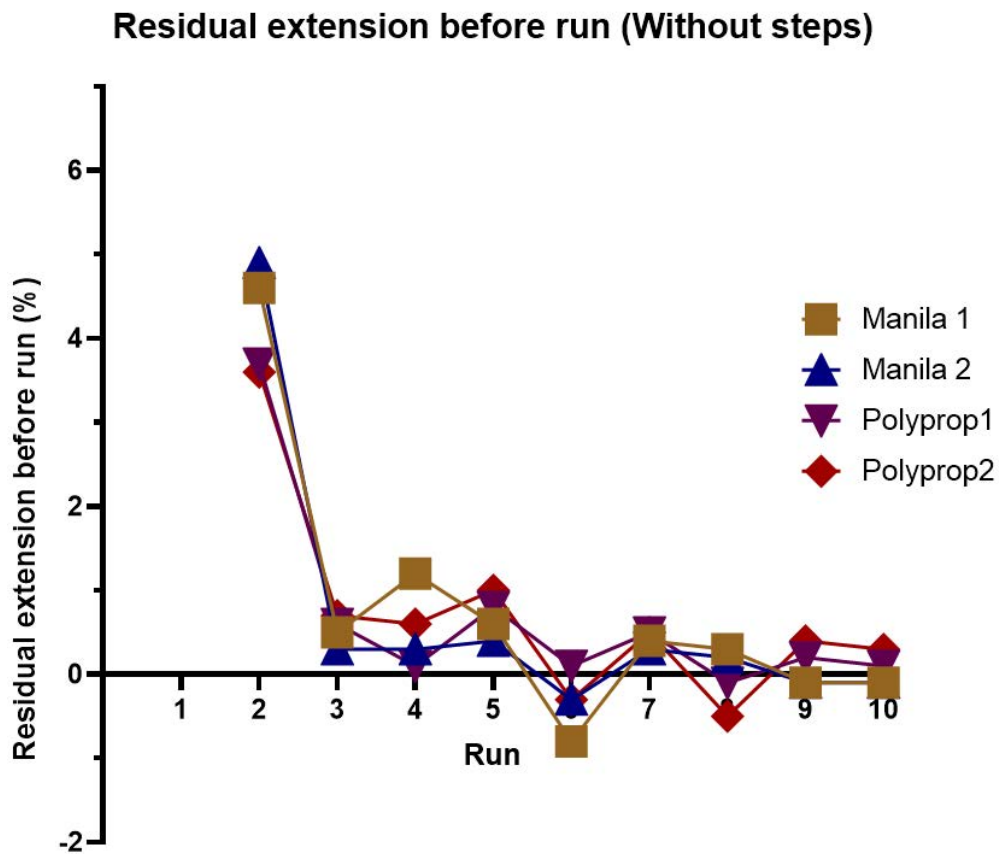
Figure 14: The residual extension in % before a run for the ropes only.

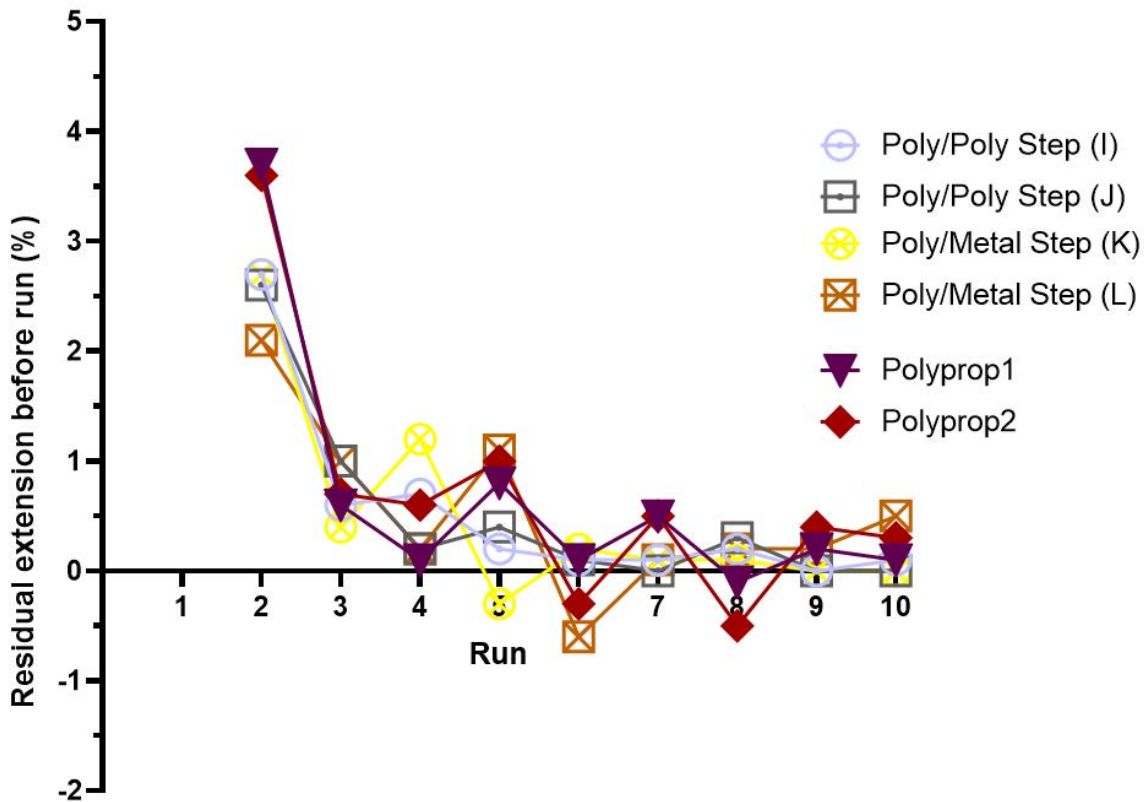
Figure 15: The residual extension in % before a run for the ropes made from synthetic fibre with and without steps.

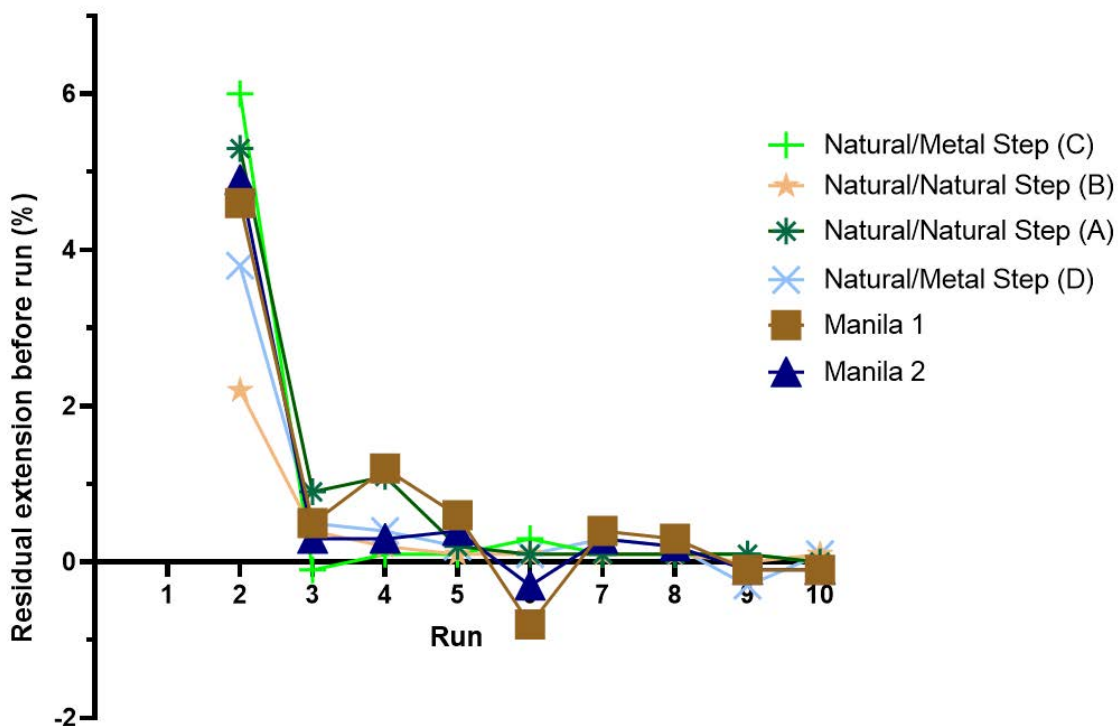
Figure 16: The residual extension in % before a run for the ropes made from natural fibres with and without steps.

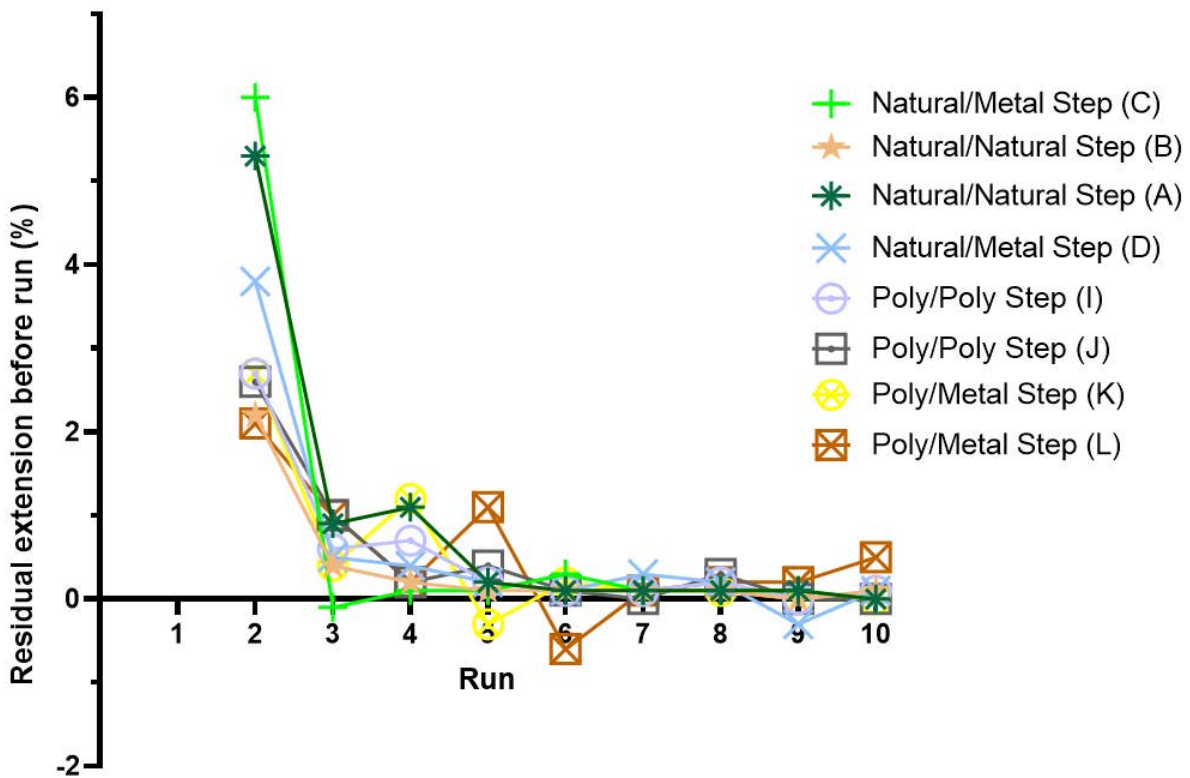
Figure 17: The residual extension in % before a run for the ropes with steps.

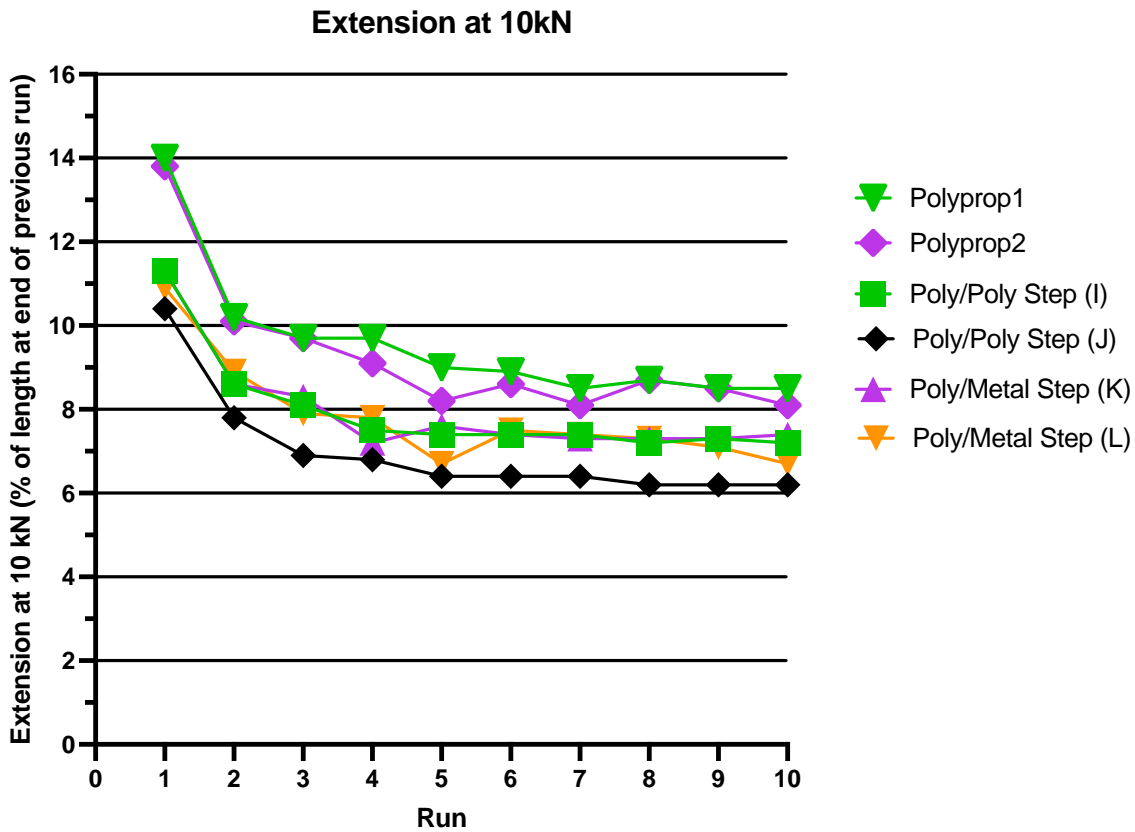
Figure 19: The extension in % with a force of 10 kN applied for the polypropylene ropes with steps.

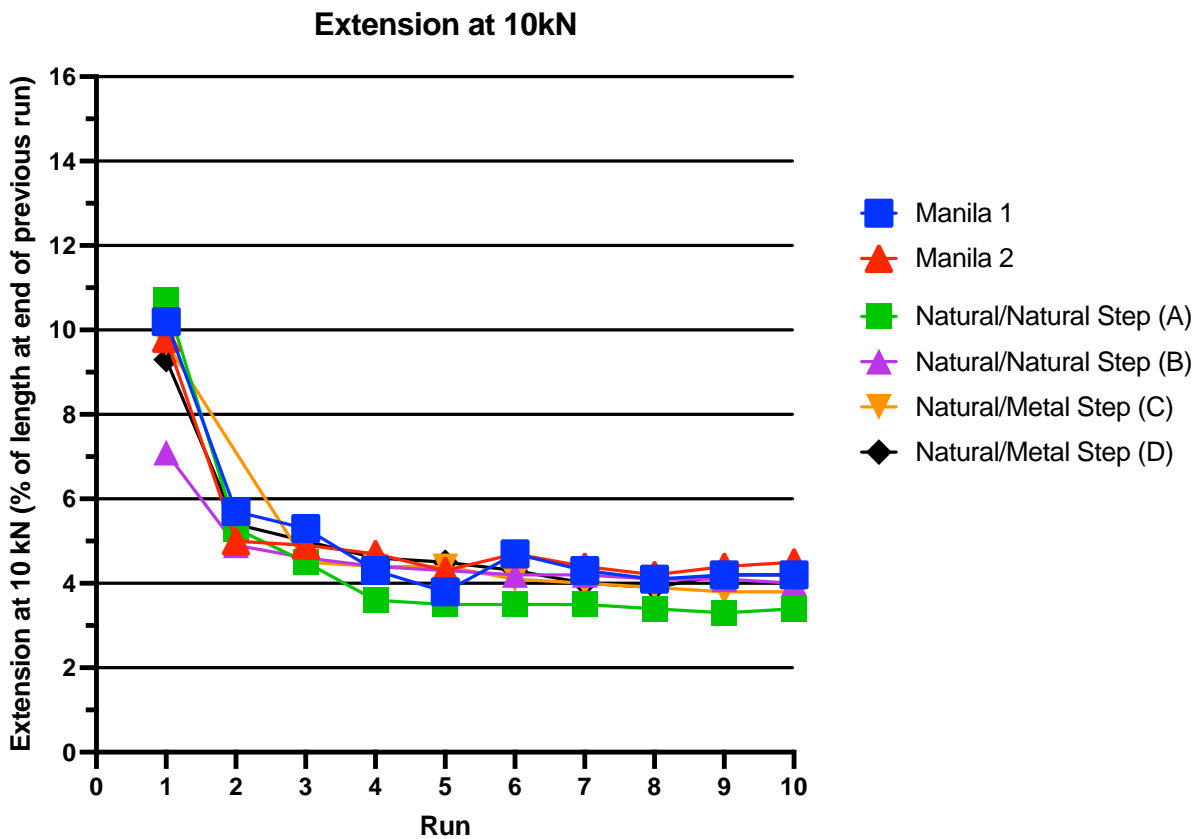
Figure 20: The extension in % with a force of 10 kN applied for the manilla ropes with steps.

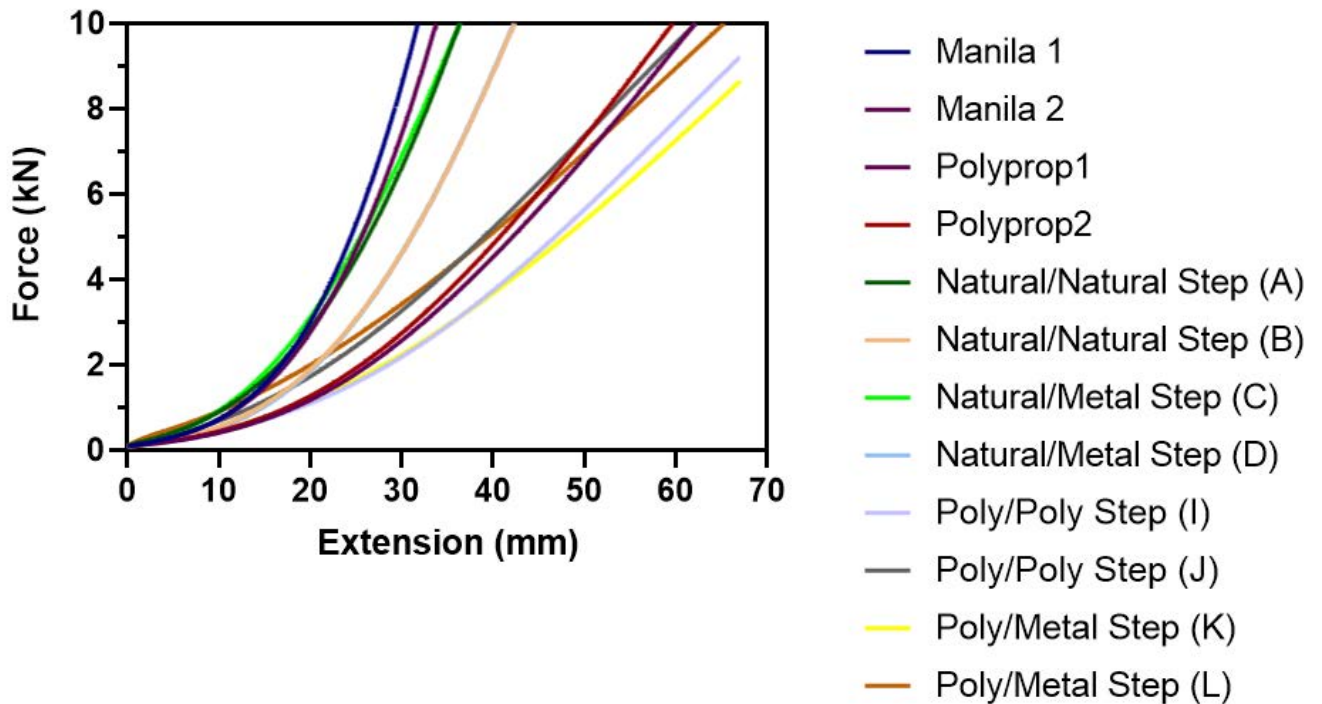
Figure 22: Performance after bedding in stress-strain graph (force-extension) of the behaviour of the ropes under test during run 10 with steps and without steps under test during test 10.

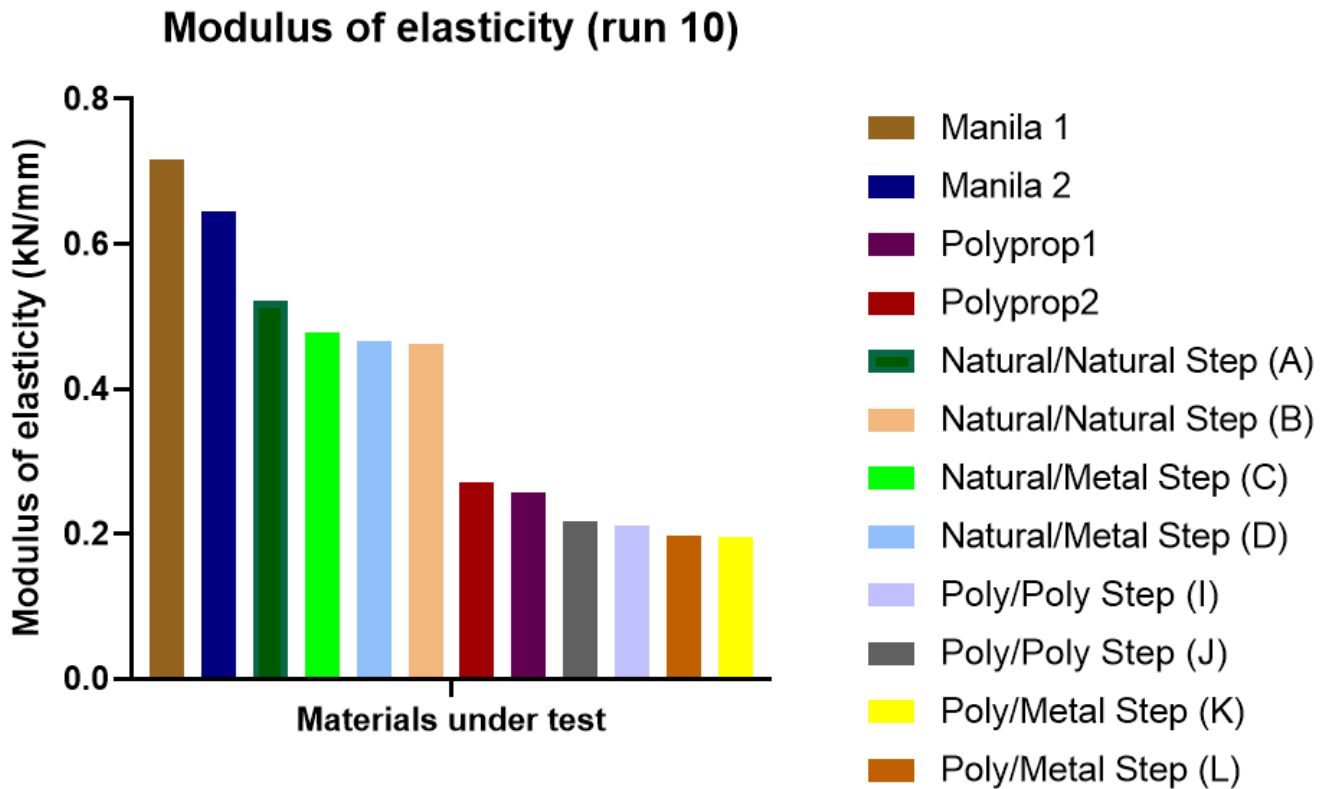
Figure 25: Stiffness data (modulus of elasticity) recorded during run 10 (linear section of data when force > 6 kN). The results are presented from highest modulus of elasticity to the lowest from left to right.

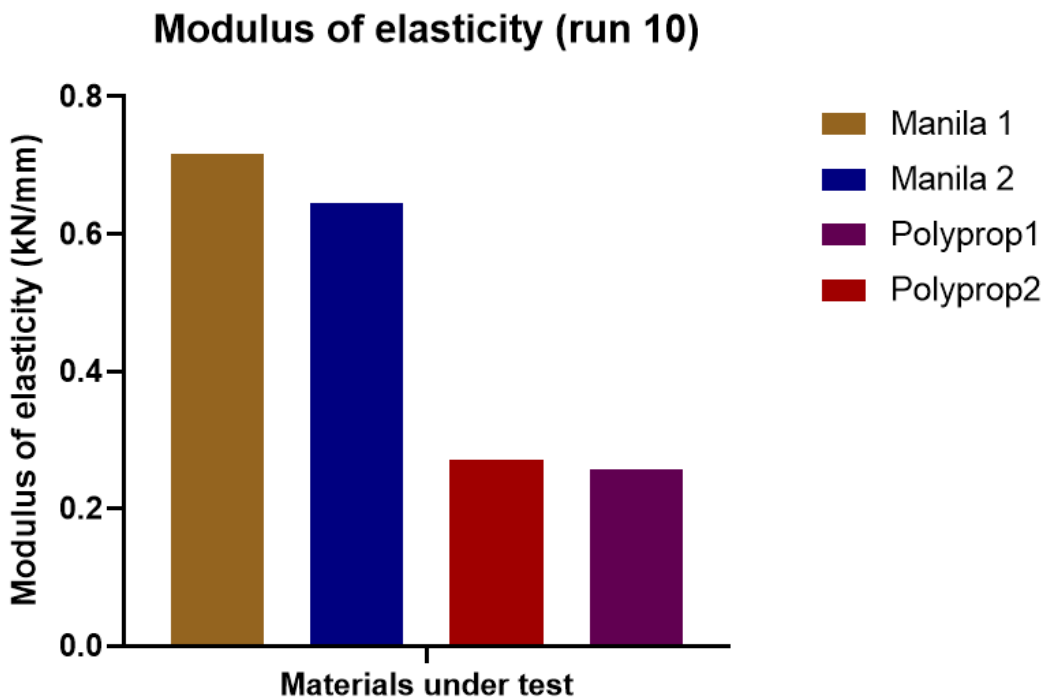
Figure 26: Stiffness data (modulus of elasticity) recorded during run 10 (linear section of data when force > 6 kN) for the ropes without steps.

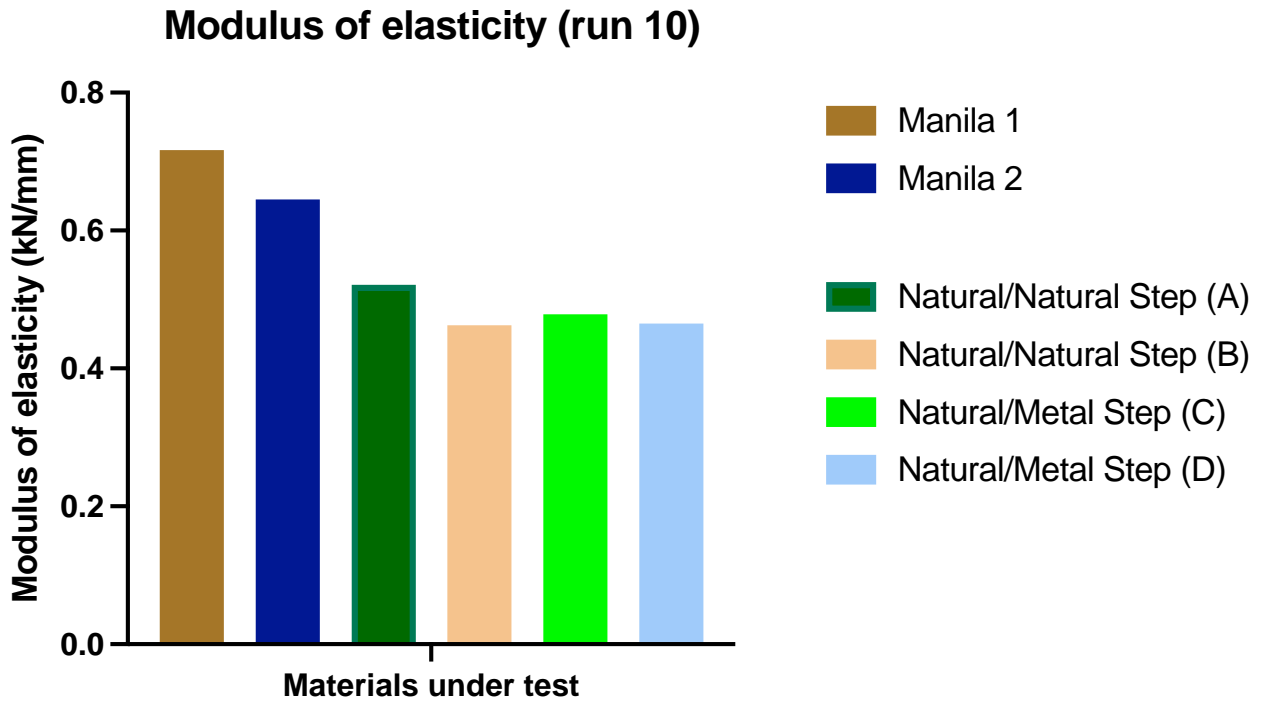
Figure 27: Stiffness data (modulus of elasticity) recorded during run 10 (linear section of data when force > 6 kN) for the ropes made from natural fibres.

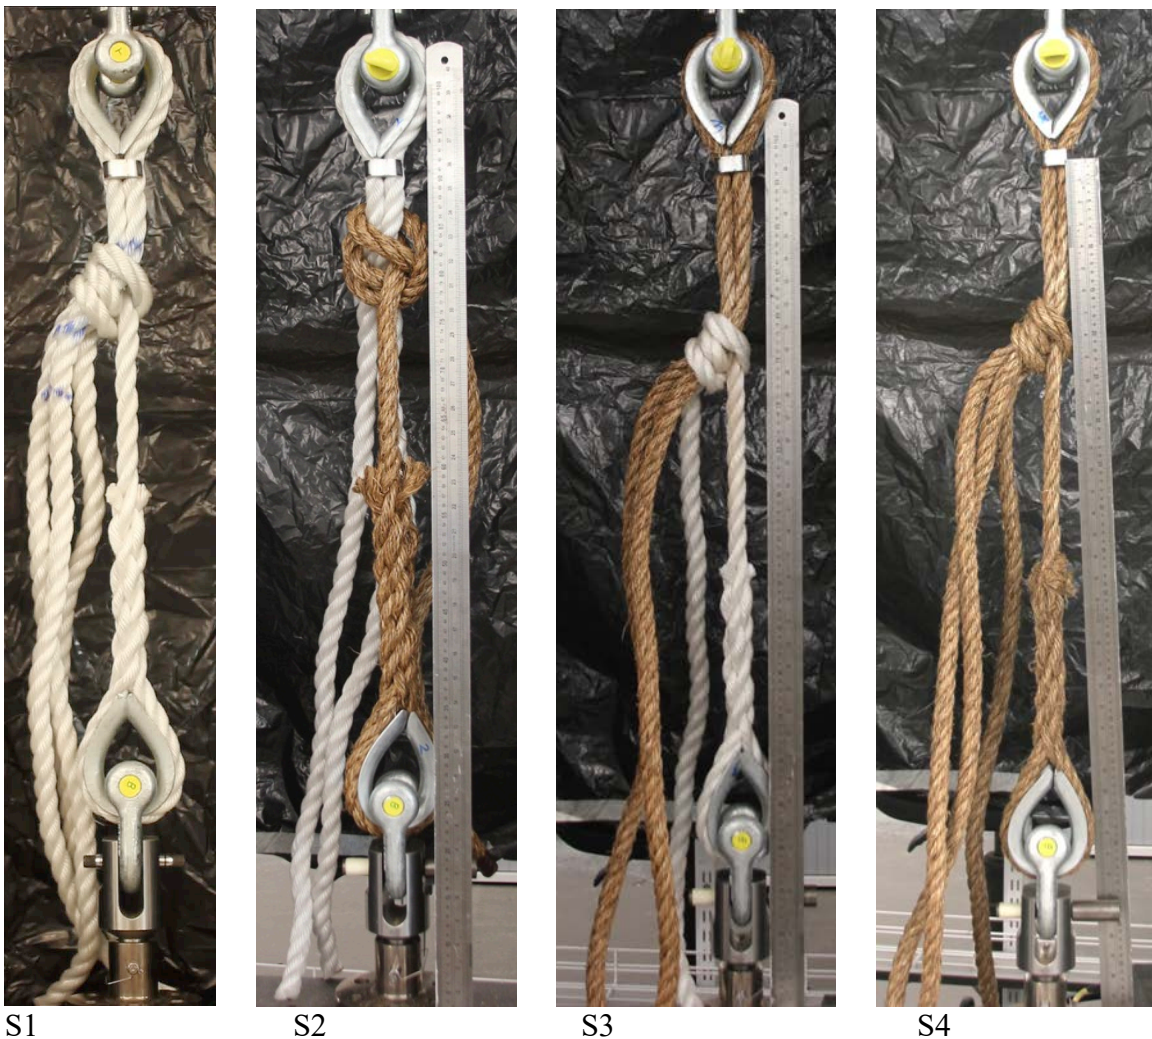
Figure 36: Initial starting positions of test runs for scenarios S1-S4.

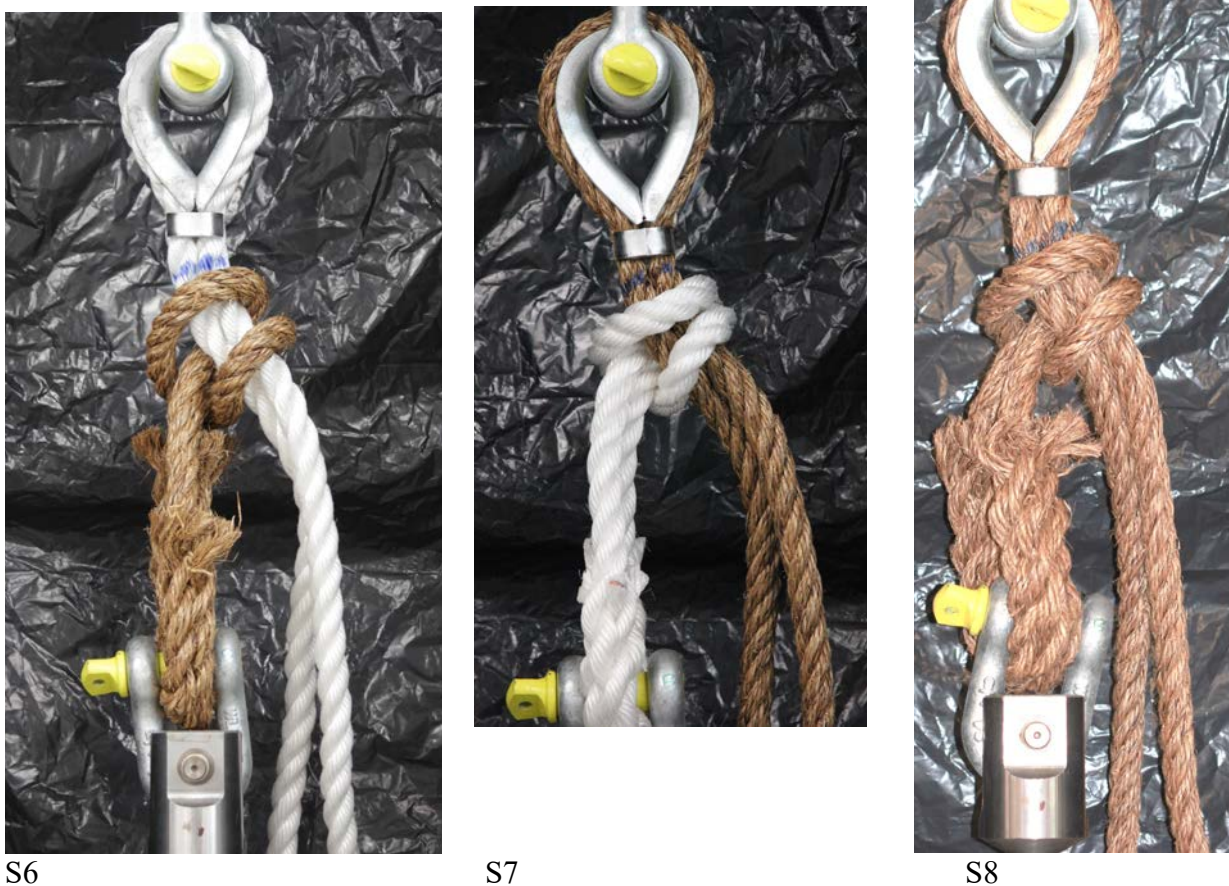
Figure 39: Views of cow hitch scenarios S6-S8.

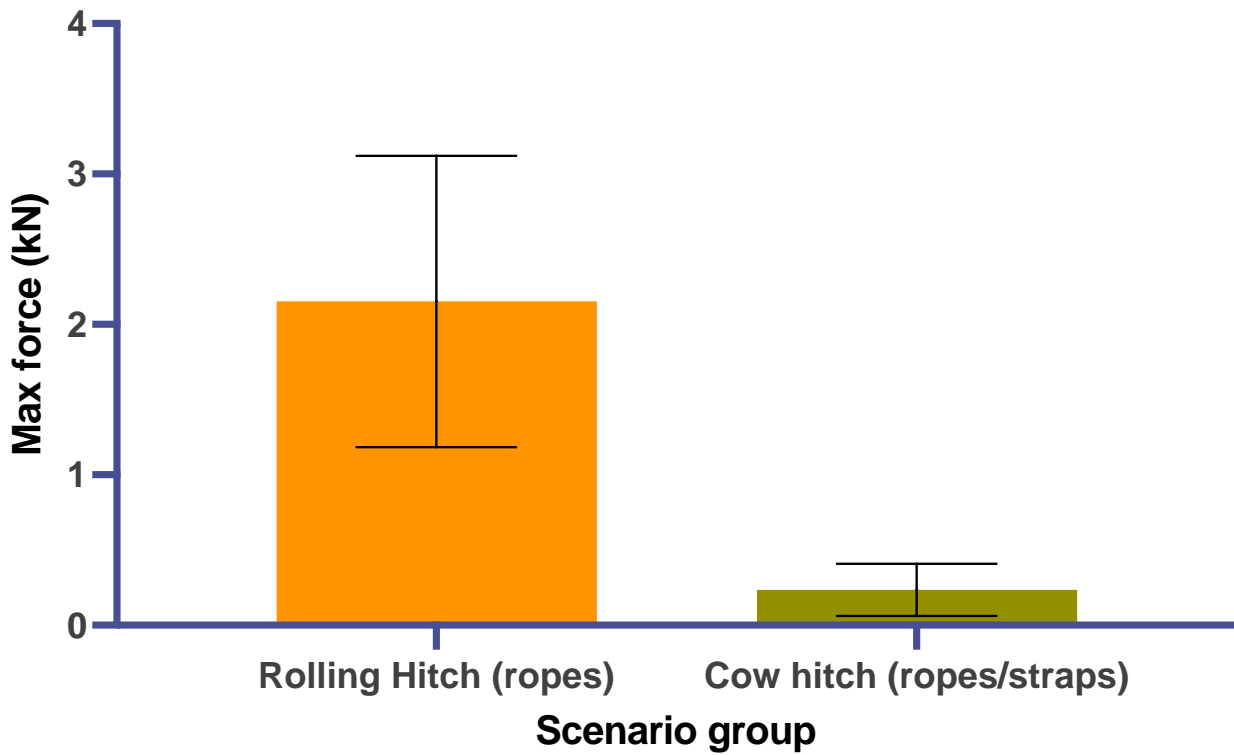
Figure 44: Average max force for rolling hitch compared with cow hitch securing methods.

The max loads reached within the WP2 testing of rolling hitch knots averaged to 2.2 kN (see Figure 44). Note that the static loads on one side of 9 metre ladder would be approx. 2.6 kN/2 = 1.3 kN (Figure 5). In the WP3 tests the max force was 2.8 kN (see Figure 6). In contrast the cow hitch knots failed to grip and instead slipped down the rope at loads less than 200 N. It can

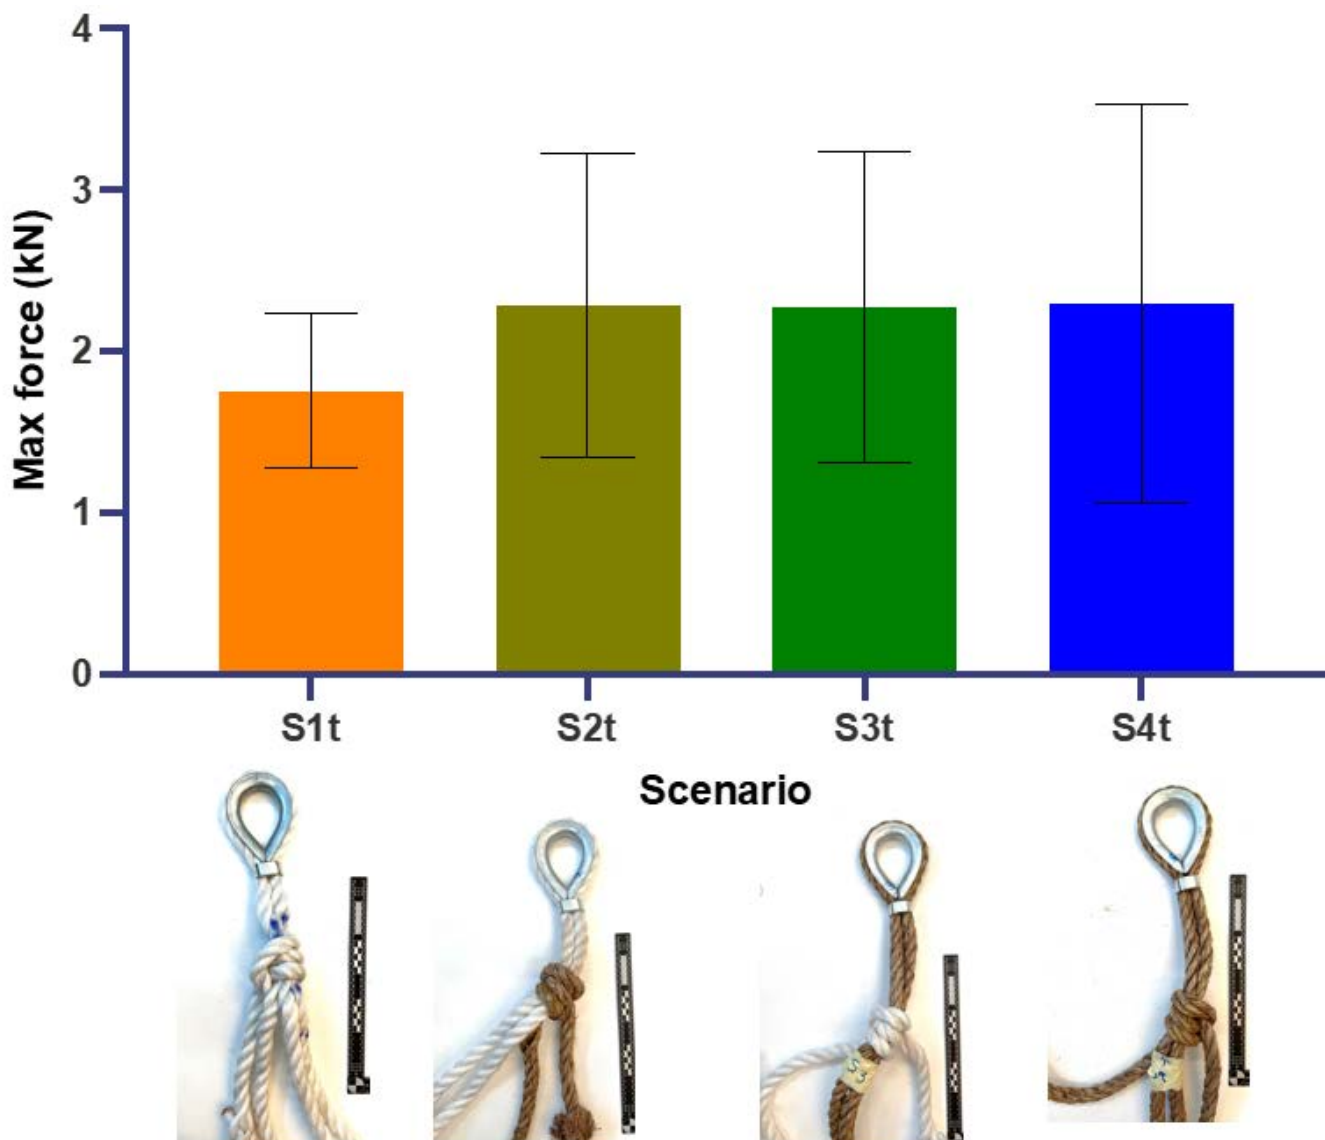
Figure 45: Max force for each rolling hitch scenario.

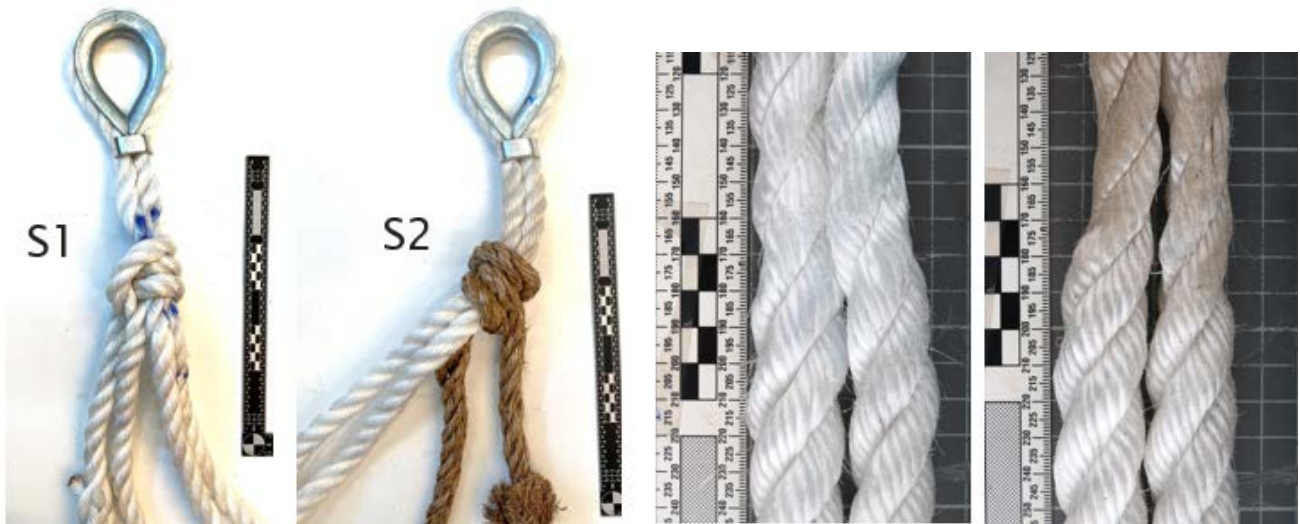
Figure 49: Scenarios 1 and 2 post-test (Left) and the examined worn section of the double rope (Right).

The ladder rope pairs were subjected to post-test inspection to identify signs of wear (Figure 49 to Figure 54). Scenarios 5 – 12 (secured via cow hitch arrangements) did not show any signs of wear after 50 runs. Some visible signs of tightening and squashing of the ladder rope pair was observed in scenarios 1 – 4 (secured via rolling hitch arrangements). The manilla on polypropylene produced a discolouration on the ladder rope pair from the manilla rope.

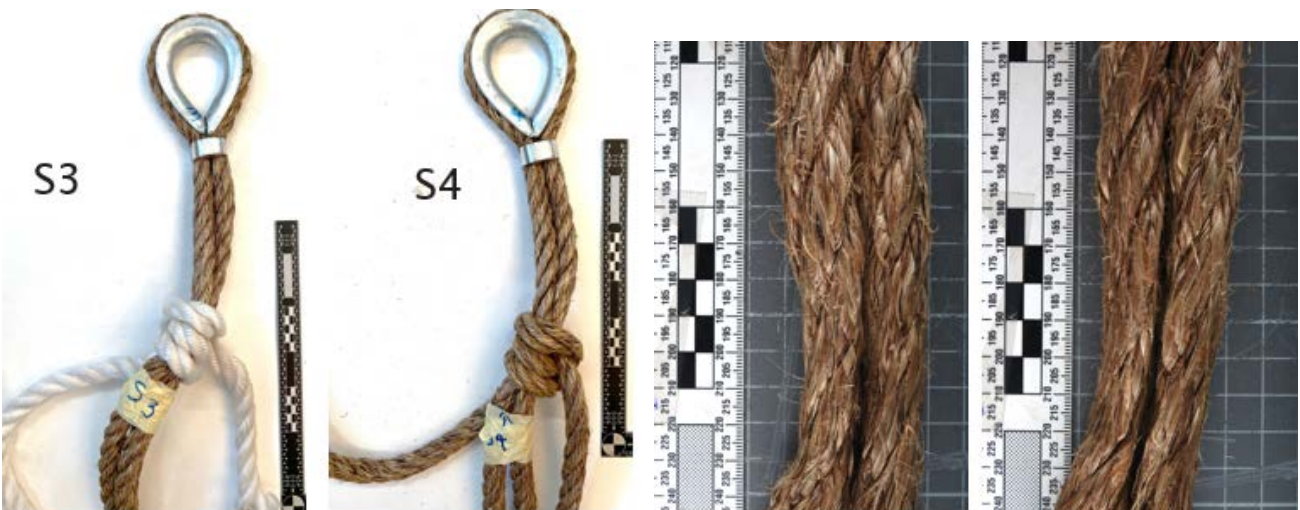
Figure 50: Scenarios 3 and 4 post-test (Left) and the examined worn section of the double rope (Right).

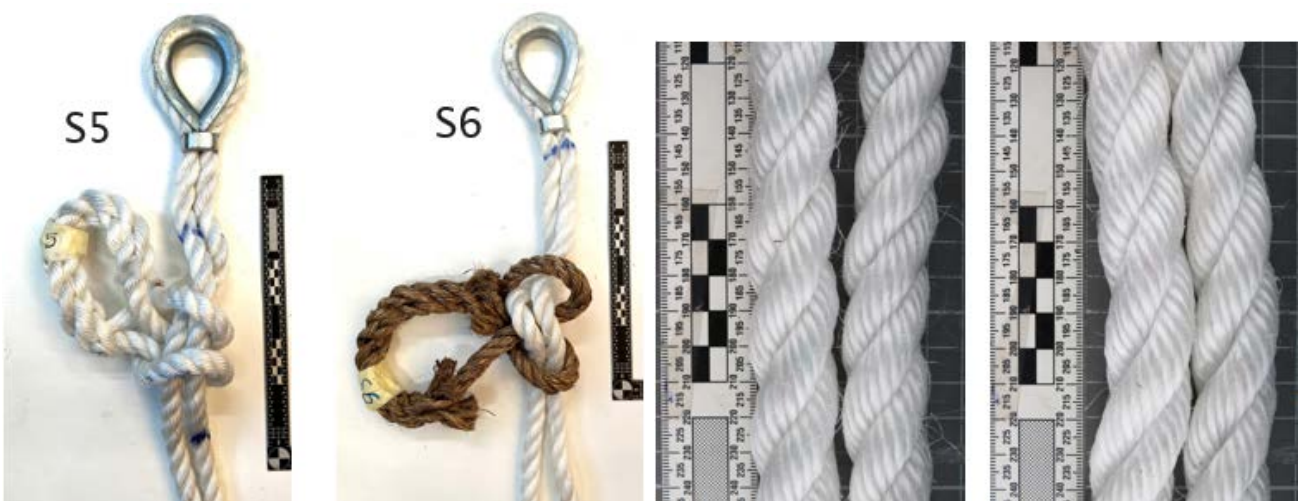
Figure 51: Scenarios 5 and 6 post-test (Left) and the examined worn section of the double rope (Right).

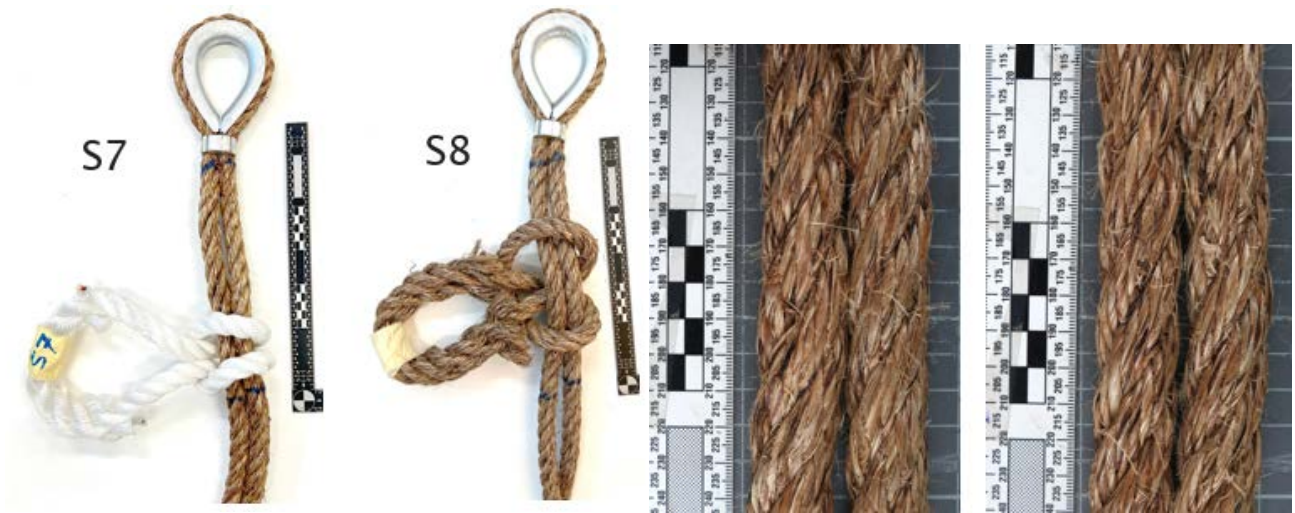
Figure 52: Scenarios 7 and 8 post-test (Left) and the examined worn section of the double rope (Right).

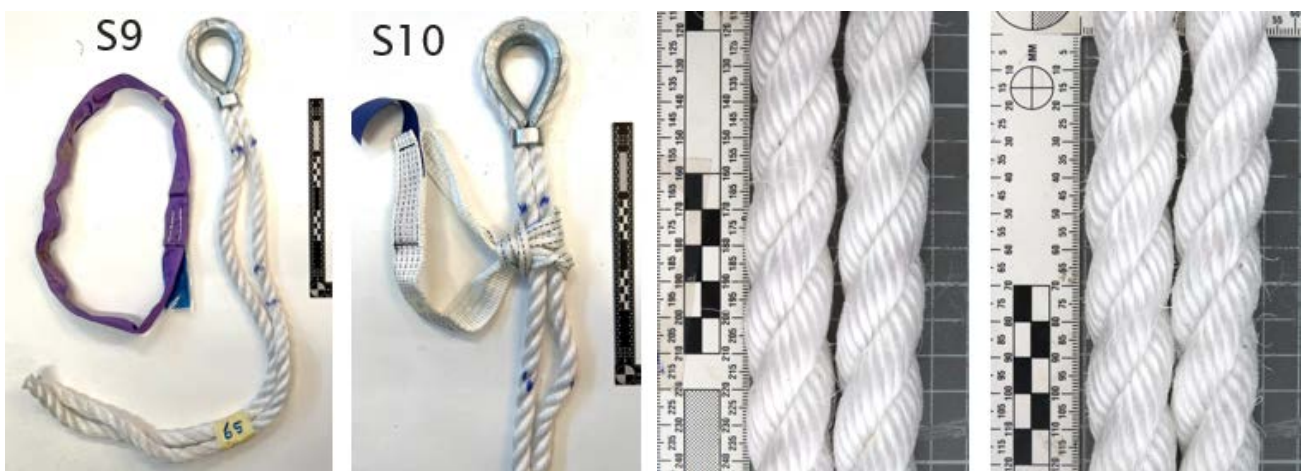
Figure 53: Scenarios 9 and 10 post-test (Left) and the examined worn section of the double rope (Right).

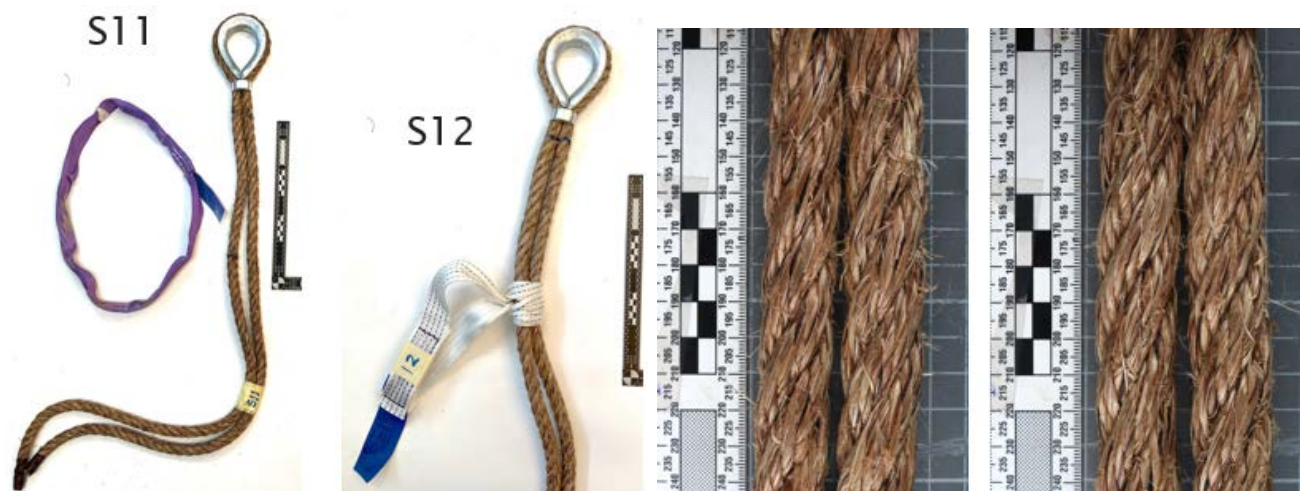
Figure 54: Scenarios 11 and 12 post-test (Left) and the examined worn section of the double rope (Right).
