Title of Work: *Securing of pilot ladders at intermediate lengths – testing*

Reference No: *NCC453*

Work for: *International Maritime Pilots Association*

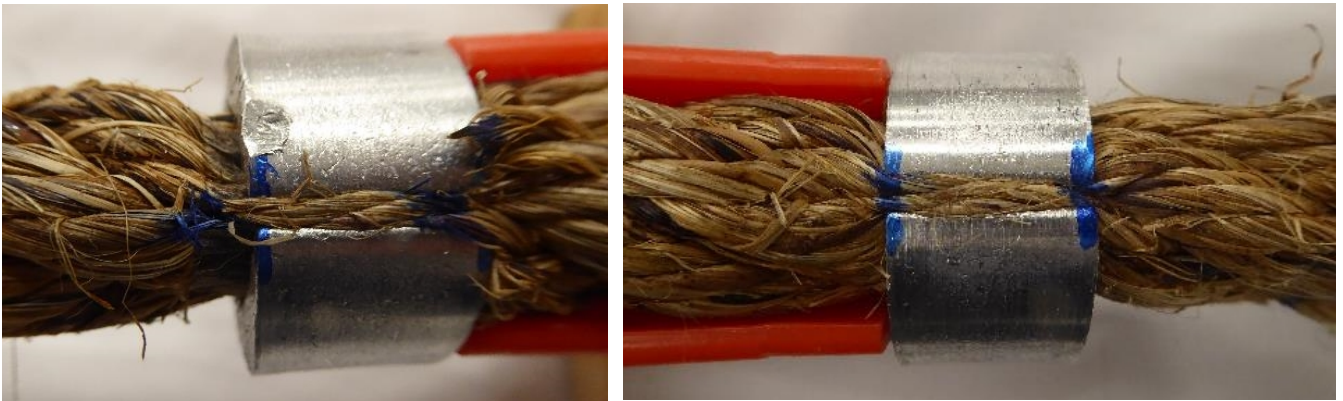
Figure 63 : Specimen H after 1500 cycles showing (Left) permanent plastic deformation to the top of the metal fastener from contact with the small shackle. The top metal fastener slipped 2 – 3 mm from its initial position during the test. (Right) No slippage was observed on the metal fastener underneath the wooden assembly.

Small shackle deforms metal fastener: The small shackle arrangement was too small to slide over the fastener and therefore the small shackle contacted the metal clip throughout the testing. After 1500 cycles, the small shackle had caused permanent deformation on the metal fastener regardless of which rope material was used (Figure 62 and Figure 63). No effect was observed on the shackle (Figure 64), hardness testing revealed that this was due to the shackle material being much harder than the metal fastener material (Table 7).

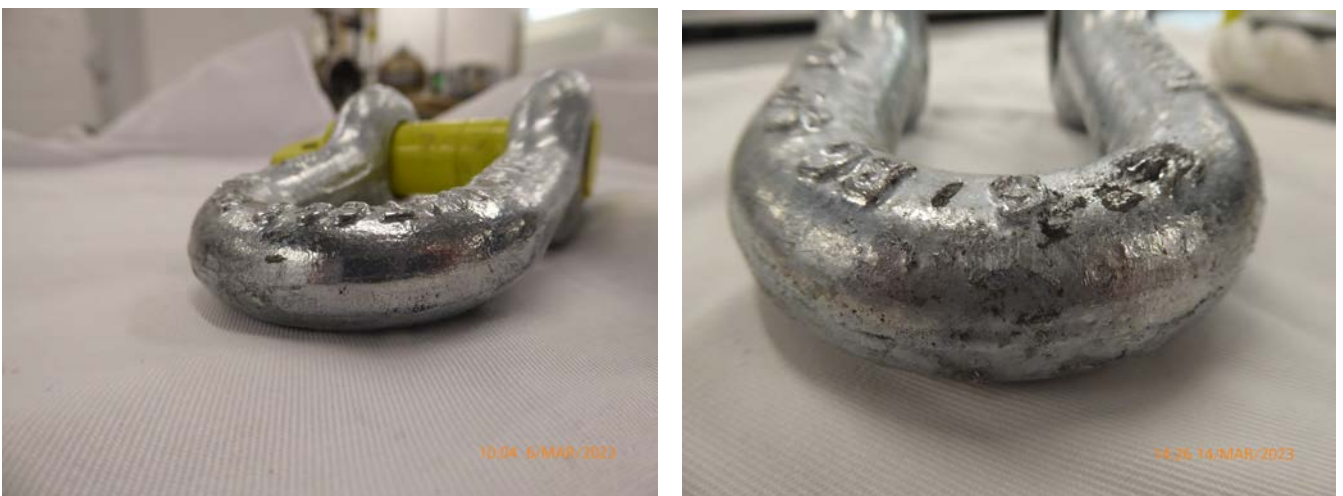
Figure 64 : No visible damage was found on the shackle after any of the tests.

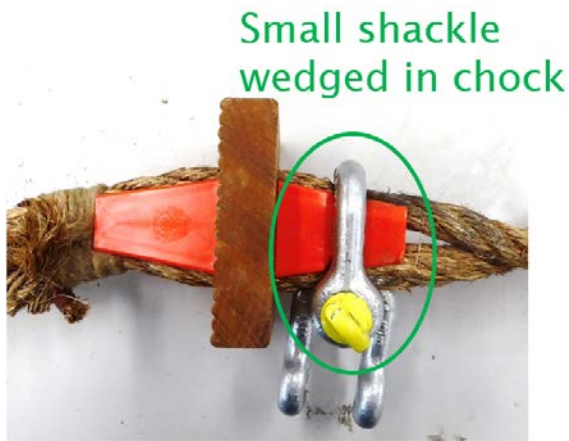
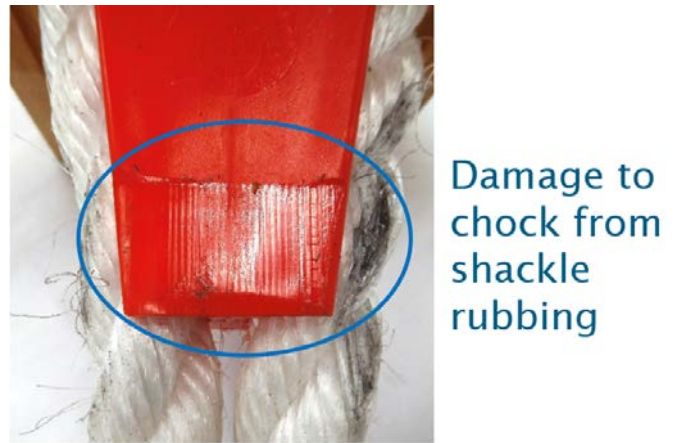
Figure 65 : The small shackle passed over the rope seizing and got wedged in the chock (Top left). When the small shackle was removed after testing, damage to the chock surface was observed (Top Right). The wedging effect resulted in the chock coming away from the wooden step during the 'ladder put away' step (Bottom left). Permanent deformation was observed to the chock (Bottom right).

Small shackle deforms plastic chock: The small shackle was able to pass over the rope seizing fastener and contact the plastic chock directly. The plastic chock tended to get wedged in the small shackle (Figure 65 top left), resulting in a lot of force and manipulation being required to remove the shackle from the plastic chock. An area of wear damage was observed on the plastic chock after removal from the small shackle (Figure 65 top right and bottom right). Due to the wedging effect, the plastic chock was forced to separate from the wooden step during the unloading step (when the ladder was put away) (Figure 65 bottom left). Potentially this

In all scenarios involving the D-shackle there was some form of damage to the rope ladder (Figure 62, Figure 65, Figure 67, Figure 69). This suggests that although an easy attachment to make there is some level of risk.

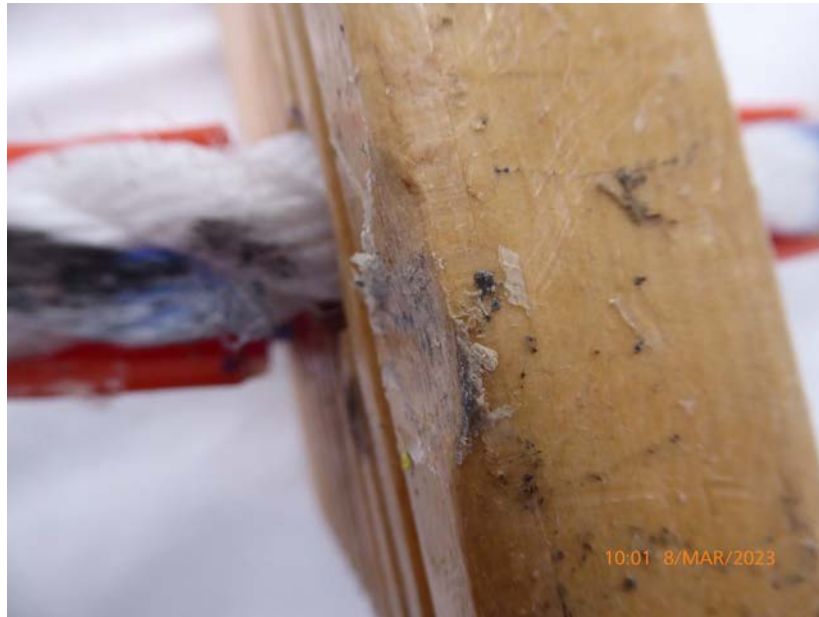
Figure 67 : Specimen N after 1500 cycles showing the damage that the large shackle did to the wooden step.

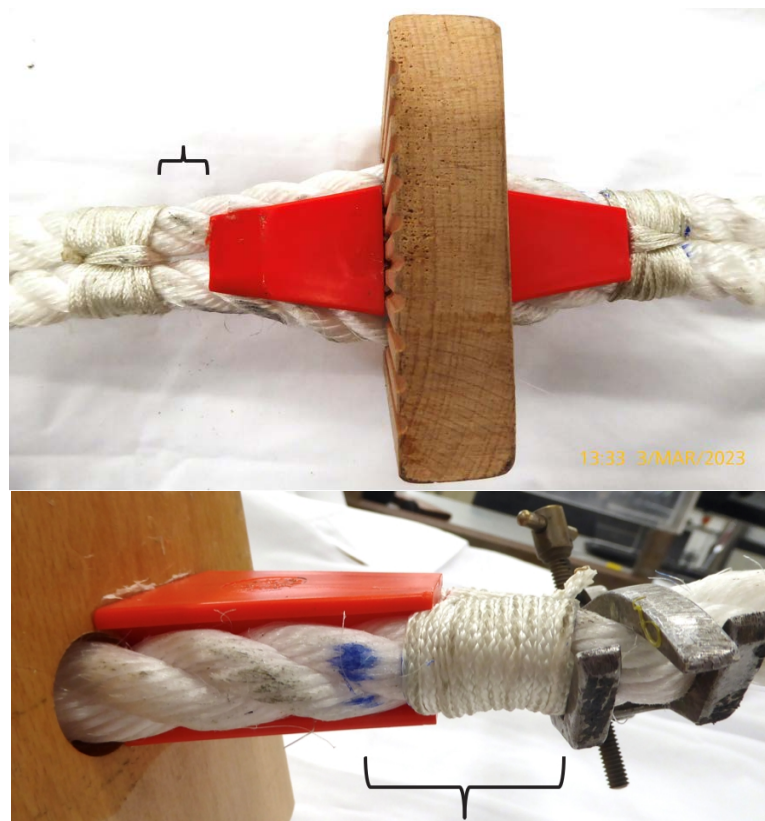
Figure 70 : Specimen M the wooden step assembly slipped downwards (top). The bottom rope seizing slipped approximately 30 mm until it was prevented from slipping due to the clamp (lower).

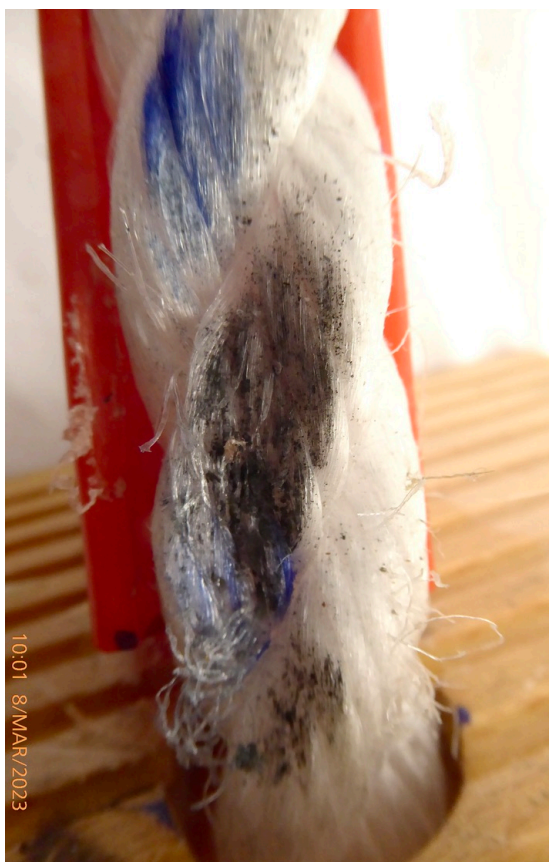
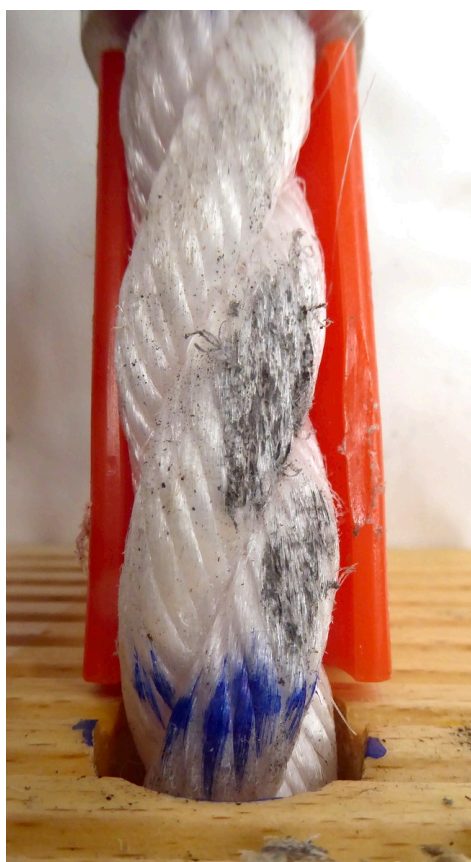
F: Maninla rope (manila seizing) large shackle. G: Maninla rope (metal clip) large shackle

N: Polyprop rope (polyprop seizing) large shackle. O: Polyprop rope (metal clip) large shackle

Figure 73 : Specimen F, G, N, and O showing damage to the rope from the large shackle.

The shackle caused rope wear: Both the small and large floating shackles wedged in between the inside faces of the chock and the rope during testing. With the addition of a release step (applied release force to simulate removing the shackles), some level of rope wear occurred to both rope materials. A black deposit can clearly be seen on the surface of the ropes (Figure 73). This black deposit is most likely due to the shackle coating rubbing on the rope surface (fretting). A more prominent black deposit can be seen on the manilla rope due to the rougher surface of the manilla rope material (Figure 73 and Figure 74). The individual strands from the polypropylene and manilla rope were observed under a macroscope after testing had been carried out. The strand with the most amount of wear for both the manilla and polypropylene rope material are shown in Figure 75. The strands remained predominantly intact with less than 10 % of the fibres, in the strand examined, becoming broken. Clearly broken fibres and obvious wear would not pass any regular inspection of the pilot ladders in-service.

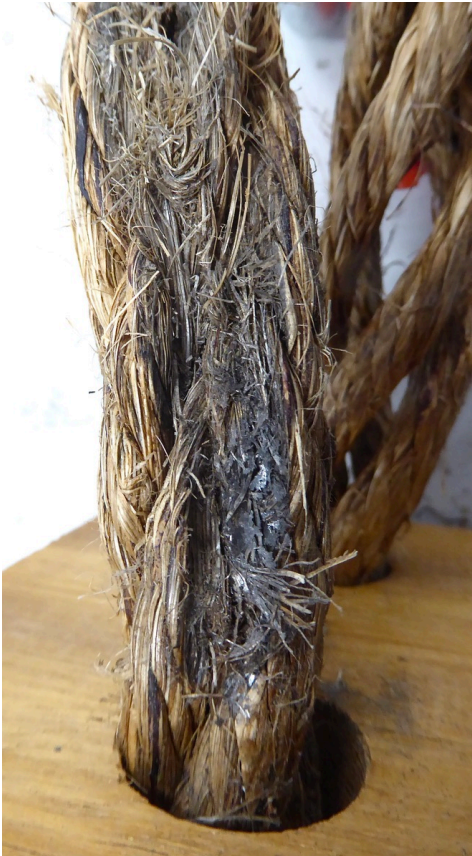
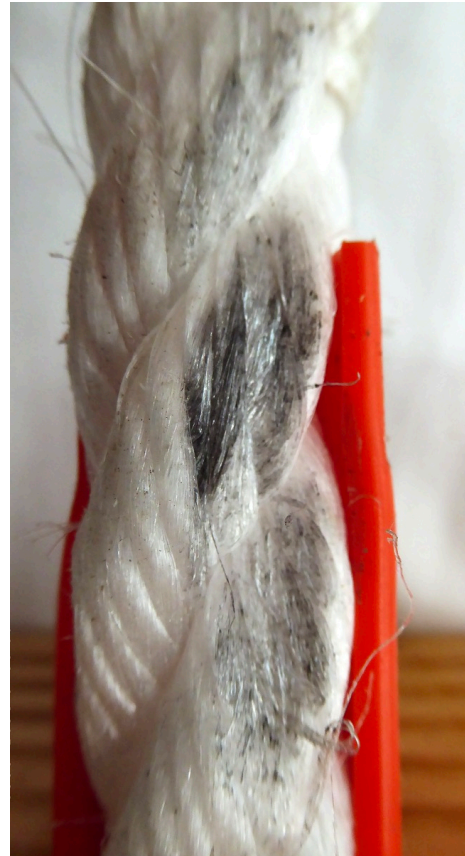
E: Manila rope (manila seizing) small shackle. M: Polyprop rope (polyprop seizing) small shackle.

Figure 74 : Specimen E and M showing the damage to the rope from small shackle rubbing – note that H and P are not shown as the small shackle stopped at the metal clip.

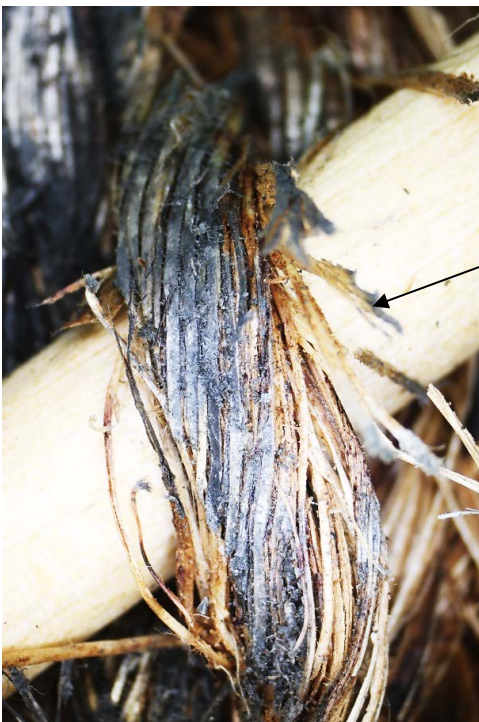
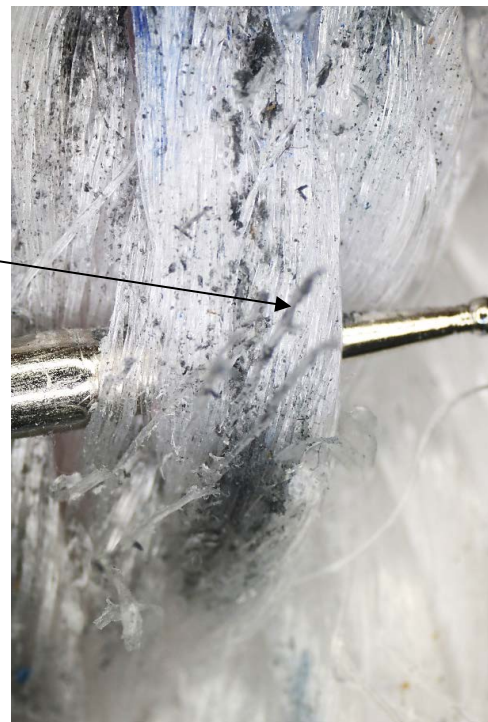
Broken fibres

Figure 75 : Macroscopic images of the worst worn strands from Manilla and the Polypropylene rope material.

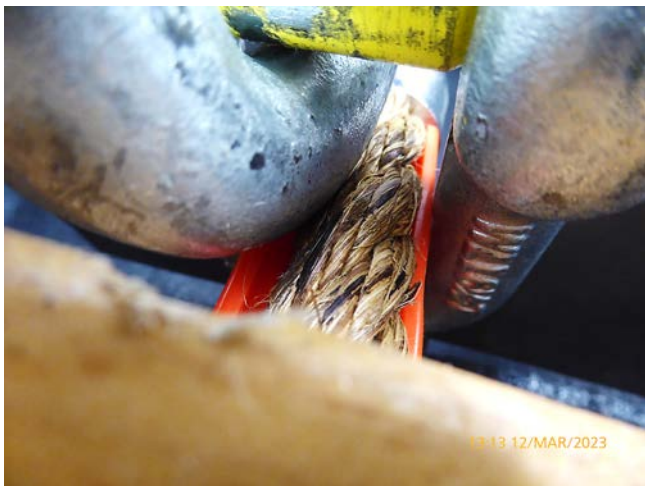
Figure 76 : Specimen G showing the progression of the rope wear during testing for 5 cycles (Top left), 10 cycles (Top right), 100 cycles (Bottom left), and 1300 cycles (Bottom right).

The rope wear was observed within the first 100 cycles: Within 5 cycles, black deposit from the shackle material coating was observed on the rope. The black deposit built up and became more prominent over a 100-cycle period. Comparing the 100th cycle to the 1300th cycle showed that the majority of the black deposit and the rope wear tended to occur in a short period of time, typically by 100 cycles (Figure 76).
